Memorandum

Re: Proposed Road Crossing Assessment for Carrington Development area

The Cortes Forestry General Partnership is proposing to develop access to the Carrington Operating Area where plans will be developed over the next few months for a longer-term selective harvest operation. The proposed road is approximately 500 metres in length with one proposed crossing structure. On August 23, 2017 I visited the proposed Carrington development area with Mark and Matt to review the plans for harvesting and as a priority, the proposed road location to access the Carrington area.

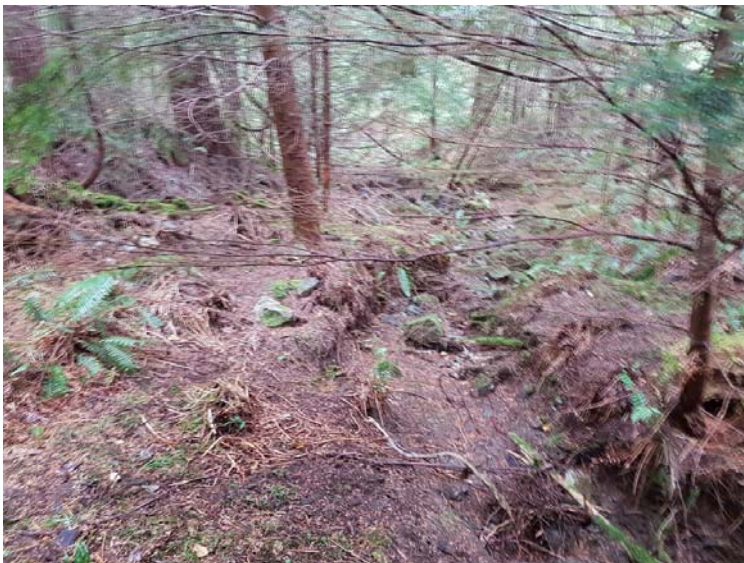
[View downstream from proposed crossing location](#)

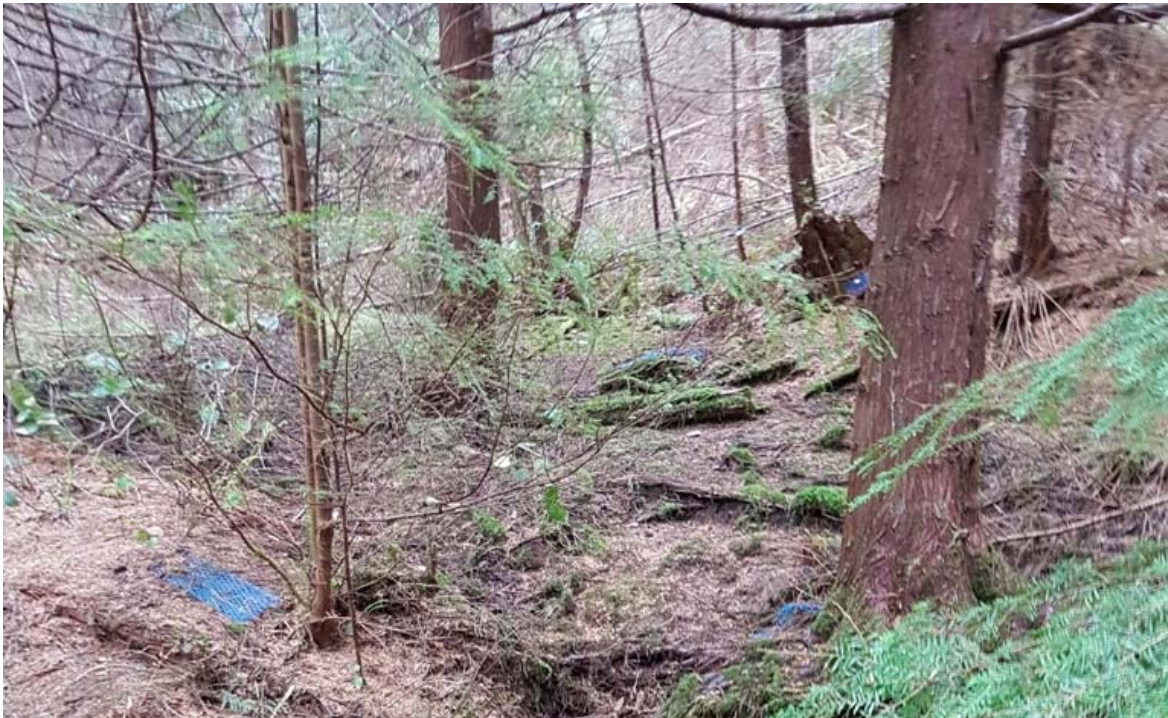
View upstream from crossing location

1. Flow – flow of water in this area is occasional only, although the area may flood periodically, there is no defined channel and no pooling of water in the vicinity of the crossing
2. Current – the permanent vegetation cover throughout this area indicates that water velocity would be very low and very occasional.
3. Cover – permanent vegetation cover throughout this area
4. Channel depth – channel is discontinuous and not defined
5. Channel width – channel is less than 2.5 metres where visible, not defined and only intermittently above ground
6. Substrate – organic materials where any type of channel is above ground; no gravel or stable debris, and no undercut banks or deep pools that would indicate fish habitat
7. General habitat type – no habitat for fish other than a low potential for fish passage at higher water levels
8. Gradient of stream – 0 – 6% (less than 3% at crossing level)

The proposed crossing meets the criteria for marginal fish habitat, as the highest possible standard for the area. It is unlikely that this site will contain fish at any time, but providing fish passage (not habitat) is not unreasonable for the area. I recommend a 600mm corrugated metal pipe (closed bottom structure) be installed and local material embedded in the pipe during construction. Further, that the construction should occur through this area when the site is reasonably dry, meaning there is no water flow through the area.
